NASA/TM-2015-218797
NESC-RP-13-00884

Spin Forming of an Aluminum 2219-T6 Aft Bulkhead for the Orion Multi-Purpose Crew Vehicle

Phase II Supplemental Report

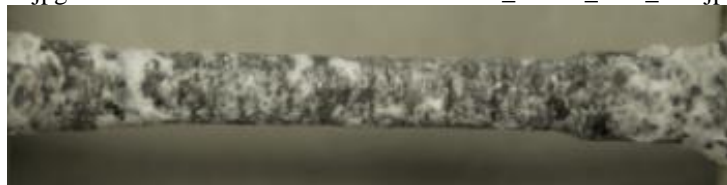
m10-16_etched_m04_50x.jpg

Coupon blank: M10
Specimen No.: M10-16
Orientation: ST
Applied stress (% YS): 75, based on MMPDS LT YS
Applied stress (ksi): 27
Failed?: No
SCC?: Yes; circled in red

(e) 75% YS (MMPDS)

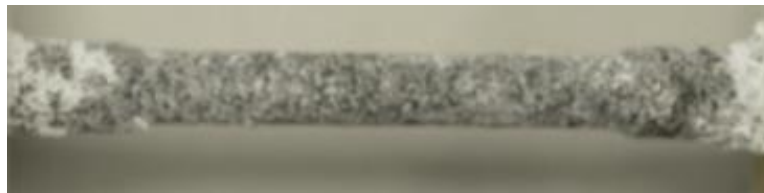
j1-8_etched_m04_50x.jpg

Coupon blank: J1
Specimen No.: J1-8
Orientation: ST
Applied stress (% YS): 0
Applied stress (ksi): 0
Failed?: No
SCC?: No

(a) 0% YS

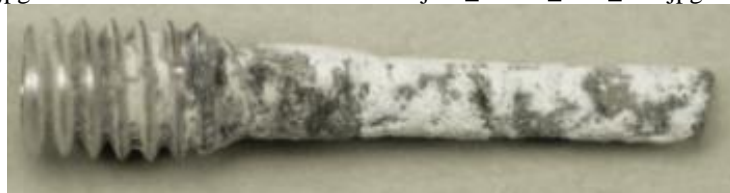
j1-2_etched_m04_50x.jpg

Coupon blank: J1
Specimen No.: J1-2
Orientation: ST
Applied stress (% YS): 75, based on MMPDS LT YS
Applied stress (ksi): 27
Failed?: No
SCC?: Yes; circled in red

(c) 75% YS

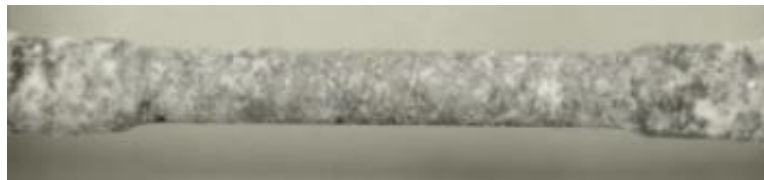
j2-8_etched_m04_50x.jpg

Coupon blank: J2
Specimen No.: J2-8
Orientation: ST
Applied stress (% YS): 0
Applied stress (ksi): 0
Failed?: No
SCC?: No

(a) 0% YS

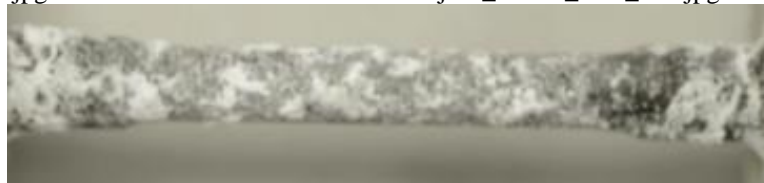
j2-2_etched_m04_50x.jpg

Coupon blank: J2
Specimen No.: J2-2
Orientation: ST
Applied stress (% YS): 75, based on MMPDS LT YS
Applied stress (ksi): 27
Failed?: No
SCC?: No

(c) 75% YS

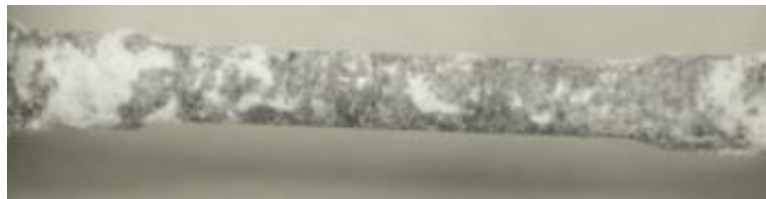
j3-8_etched_m04_50x.jpg

Coupon blank: J3
Specimen No.: J3-8
Orientation: ST
Applied stress (% YS): 0
Applied stress (ksi): 0
Failed?: No
SCC?: No

(a) 0% YS

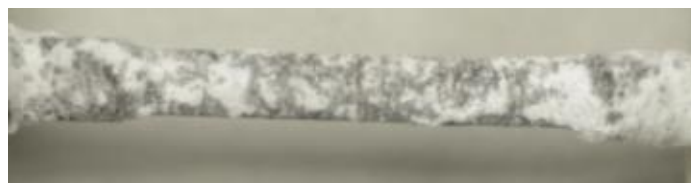
j3-3_etched_m04_50x.jpg

Coupon blank: J3
Specimen No.: J3-3
Orientation: ST
Applied stress (% YS): 75, based on MMPDS LT YS
Applied stress (ksi): 27
Failed?: No
SCC?: No

(c) 75% YS

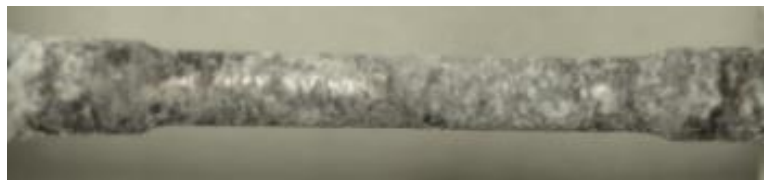
cp-p2_etched_m04_50x.jpg

Coupon blank:	CPST dome; pole region
Specimen No.:	CP-P2
Orientation:	ST
Applied stress (% YS):	0
Applied stress (ksi):	0
Failed?:	No
SCC?:	No

(a) 0% YS
